## Cone Penetration Testing (CPT) for the Tailings Dam Facility - Ghana

Client: Knight Piésold  
Location: Tarkwa, Ghana  
Period: April 2010

### Cone Penetration Testing (CPT) for the Tailings Dam Facility, Goldfields Tarkwa Mines, Ghana

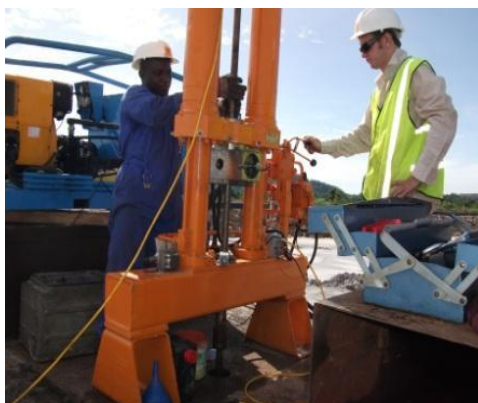
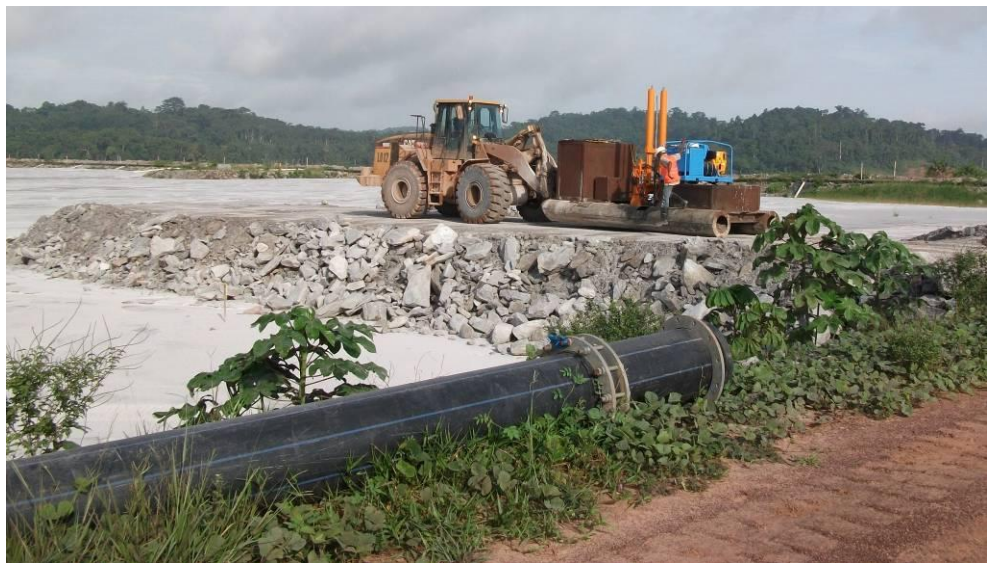
A20 tonne Capacity Stand Alone CPT equipment was used with a 220 tonne capacity Hydraulic Ram set. The CPT equipment has been installed on a skid which is filled with sand to reach the required counter weight to carry out the tests.

A total of 8 CPT were executed directly on the Tailings Dam to a maximum depth of 20m. After the desired depth
