Client
Puma Energy

Location
Canal di Vridi, Ivory Coast

Replacement of 4 x No 50tons Bollards with 100tons and Additional Terminal Investigations of Petroleum Terminal, Canal di Vridi, Port of Abidjan, Ivory Coast

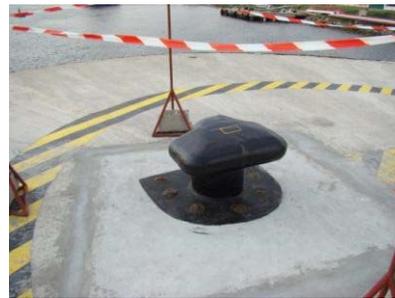
A 2mx2mx1.1m excavation was done by breaking the concrete with a compressor and a hammer. Care was taken not to damage the existing rebar. The new 100 ton bollard was secured in place and installed. C45 premix concrete was used. Cement solution and Sika Latex chemical was applied on the excavated face to ensure proper bonding between the old concrete and the new one.

PMI prepared a method statement for the replacement of all 4 x 50 ton bollards with 100 ton. PMI mobilized to the site for the replacement of the failed 50 ton bollard with a new 100 ton after which the contractor continued with the replacement of the other three, with PMI managing affairs.
