**Client**  
SRK Consulting

**Location**  
Modikwa TSF,  
Burgersfort, South Africa

### Modikwa Tailings Dam Complex, Burgersfort, South Africa

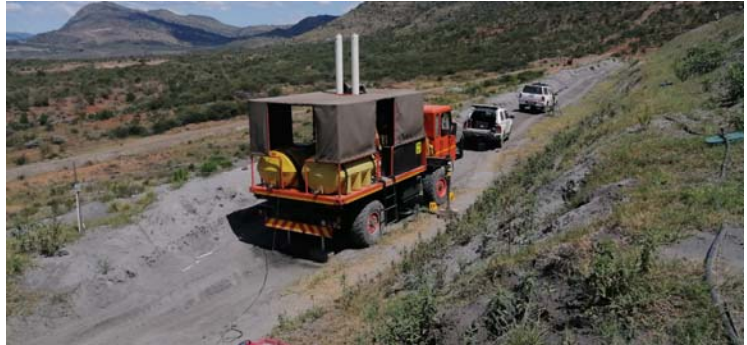
An oversized heavy-duty cone tip was fitted to the piezometer, in order to create a pushing lip surface. This is illustrated in the image below.

The push in piezometer is inserted into the hole. Using the CPT hydraulics in combination with the CPT rods, the piezometer is advanced down the hole

to the required depth by pushing on the oversized lip of the cone tip.
